Service Bulletin

Mazda Motor of America, Inc.
7755 Irvine Center Drive
Irvine, California 92718
Telephone (714) 727-1990

Category 14	Applicable Model/s 1988-1989 626/MX-6	Subject WIND NOISE	Bulletin No. 064/89 Issued 4/11/89 Revised
----------------	---	---------------------------	--

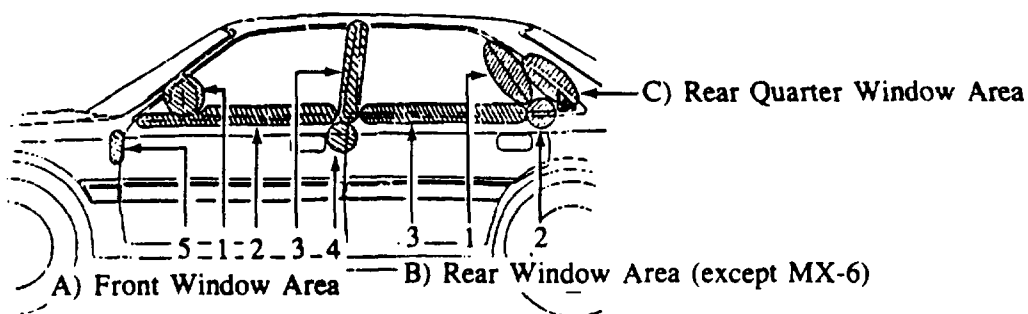
- A) Wind noise at front door area during high speed driving
- B) Wind noise at rear door corner area
- C) Wind noise/fluttering noise at rear corner window area

For examples of areas mentioned, see illustration below.
