# Service Bulletin

Category S	Applicable Model/s 1988-91 MX-6/626	Subject  WIND NOISE	Bulletin No. 004/93 Issued 2/12/93 Revised
---------------	---	---------------------------	--

**NOTE:** This bulletin supercedes Service Bulletin # 036/92, Cat. S, issued 7/7/92.

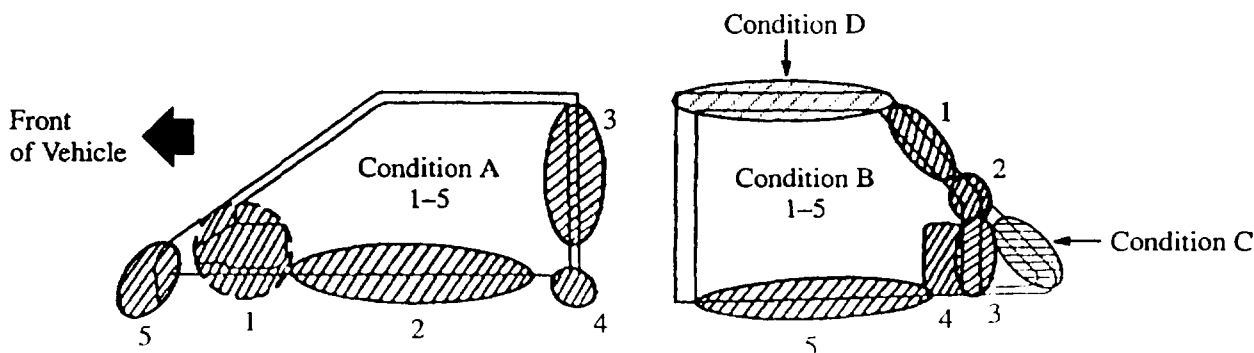
The illustration below shows the general areas where wind noise may occur (A-D). Specific locations of wind noise are shown numerically.

- A) Wind noise at front door area during high speed (above 40 mph) driving (pages 2 through 7).
- B) Wind noise at rear door area (pages 8 through 11).
- C) Wind noise/fluttering noise at rear corner window area (pages 11 and 12).
- D) Wind noise from front and rear door area due to window drop (page 13).

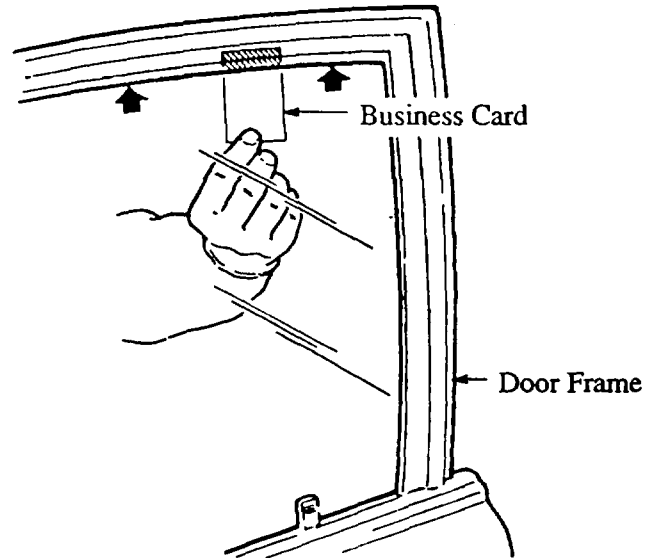
1. Use a business card as you would a feeler gauge to check for looseness (gaps) between the door glass and weatherstrip. The weatherstrip should press firmly against the glass around the entire door frame. Areas that do not form a tight seal between the glass and weatherstrip may allow the glass to drop thereby causing air leaks.
2. With the window in the down position, remove the following parts according to Workshop Manual procedures section S:
  - a) Black Plastic Inner Sail Garnish
  - b) Window Frame Weatherstrip
3. Remove the weatherstrip to access the glass run channel frame.
4. Carefully bend the weatherstrip frame slightly outward ( $1/16''$ ) to increase the pressure of the weatherstrip against the glass. Use a sheet metal bending tool (Snap-on P/N VP8R or equivalent).
