Service Bulletin

Mazda Motor of America, Inc.
7755 Irvine Center Drive
Irvine, California 92718
Telephone (714) 727-1990

Category 14	Applicable Model/s 1988-1989 626/MX-6	Subject WIND NOISE	Bulletin No. 064/89 Issued 4/11/89 Revised
----------------	---	---------------------------	--

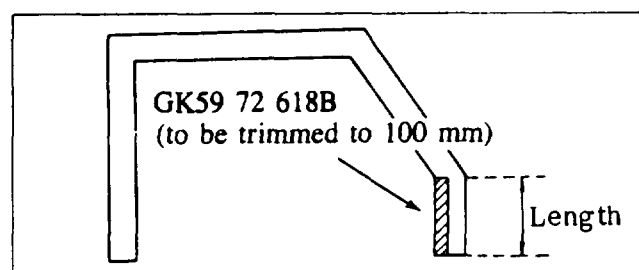
Condition B: Wind Noise at Rear Door Corner Area

6. Using a flat screwdriver, remove the inner sail garnish by prying it out at the area shown by illustration and install a new level inner sail garnish.

NOTE: Using a flat screwdriver, pry sail garnish out of its location, starting from the lower rear corner then working forward (as per illustration). Also, care must be taken not to damage paint on the surrounding area.
